Manhole Inspection Summary

Manhole # S39C2_027MH

Location Address: **4117 6th St**

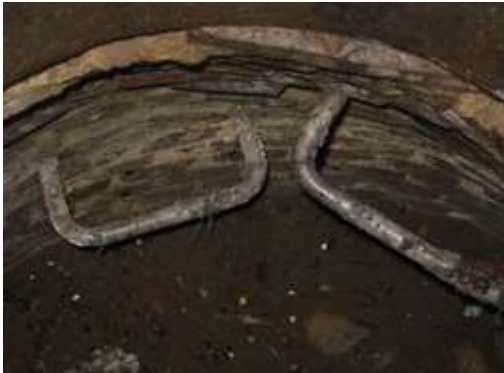
Top View

steps

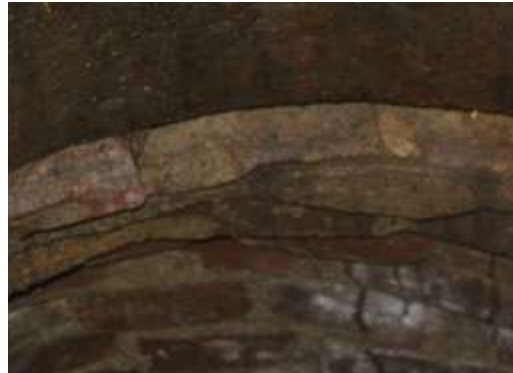
Defect 1

Condition: ☐ Sound ☒ **Cracked** ☐ Root Intrusion ☒ **Loose Brick** ☐ Deteriorated

loose brick on chimney

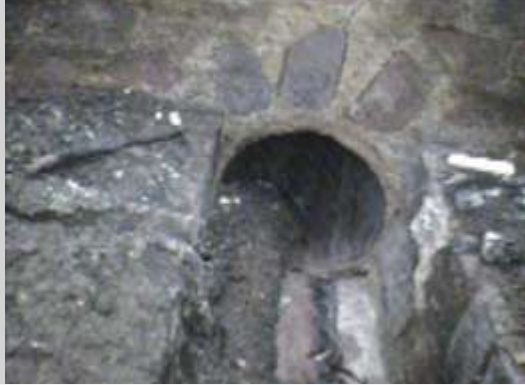
12 O'Clock Outflow

8 in. Circular Gravity Sewer
Pipe Out @ 12 O'Clock

Pipe Height: **10.8** (in.) Rod and Bar (Angled)
Pipe Material: **Clay** ☐ Pipe Lined
Invert Depth: **6.11** (ft.) Flow Characteristics: **None**
Deposits: ☒ None ☐ Mud ☐ Sludge ☐ Debris ☐ Grease
Silt Depth: (in.) Deposits Extent:
Infiltration: **None** Pipe Seal Cond: **Sound**

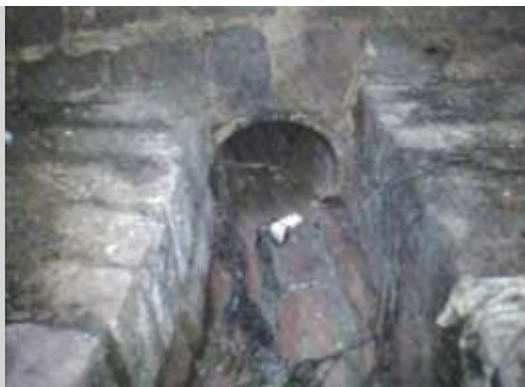
5 O'Clock Inflow

6 in. Circular Service Sewer
Pipe In @ 5 O'Clock

Pipe Height: **7.2** (in.) Rod and Bar (Angled)
Pipe Material: **Clay** ☐ Pipe Lined
Invert Depth: **5.84** (ft.) Flow Characteristics: **None**
Deposits: ☒ None ☐ Mud ☐ Sludge ☐ Debris ☐ Grease
Silt Depth: (in.) Deposits Extent:
Infiltration: **None** Pipe Seal Cond: **Sound**
